# Loss Bulletin

## Vero Equipment Breakdown Insurance

### Business sours with failed milk vat

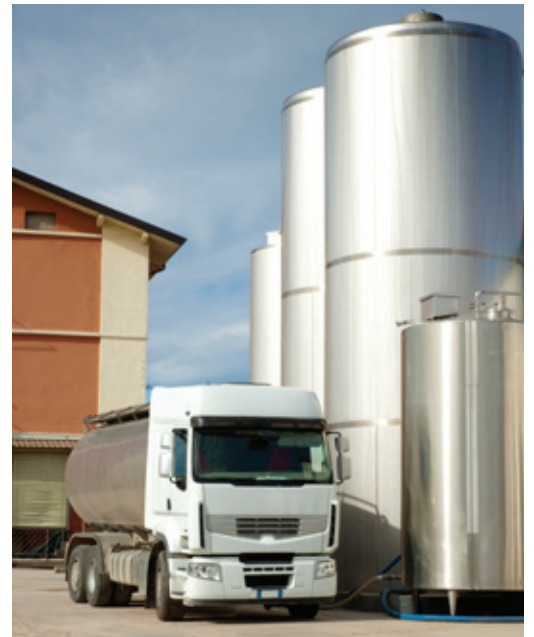
During the yoghurt making process the insured found metal shavings that were traced back to the milk vat's water jacket cooling system, which was found to have suffered a significant failure.

While the exact cause was unable to be determined, it was believed to most likely be a manufacturing or structural defect that ultimately led to the premature breakdown of the equipment.

The vat - just 6 months out of warranty - was deemed unrepairable due to the extent of damage so replacement was the only option.
