Loss Bulletin

Vero Engineering Insurance

Diesel generator

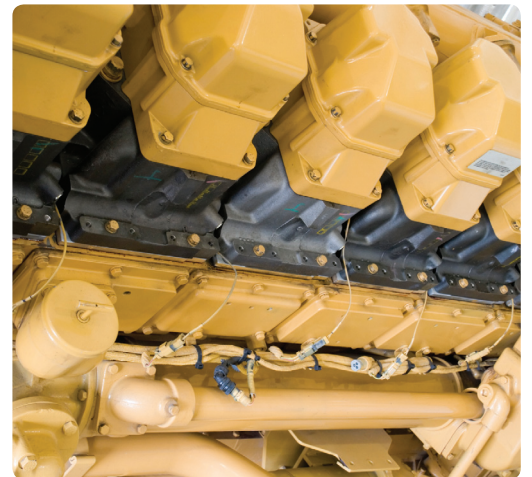
An examination of the Generator by a Technician concluded that there was no water in the cooling system, the engine sump was full of oil and water and that motor oil was leaking from every access and exit points of the engine.

The final cause could not be established, but it was narrowed down to either overheating following coolant pipe failure, loss of oil following engine block failure, or due to a fractured jacket of the Engine block.

Due to the extent of the damage and anticipated problems in sourcing replacement parts, it was decided that the best option would be to source a complete Generator of similar capacity for the Insured. In the interim, a rental generator was sourced until the suitable permanent replacement was found.

A new replacement Diesel Generator was purchased and installed for \$221,365
