Loss Bulletin

Vero Engineering Insurance

Gradual Deterioration of Insulation Causes Sewerage Pump Breakdown

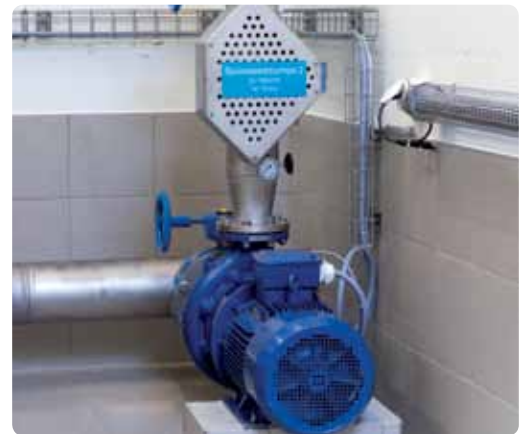
Due to insulation failure on a sewerage cutter pump, the stator windings failed causing the pump to break down. The pump was submerged in a sewer pit used by a shopping centre. Over time, the insulation on the electrical cable supplying the pump deteriorated, causing the breakdown.

For the pump to be repaired the pit needed to be emptied of the existing waste and once that had been completed the repairer was able to access the pump and carry out the repairs. As the repairs could not have been carried out without emptying the pit, the cost of the sanitation company was included in the claim settlement.
