Loss Bulletin

Vero Engineering Insurance

Servo-press

300 tonne servo press

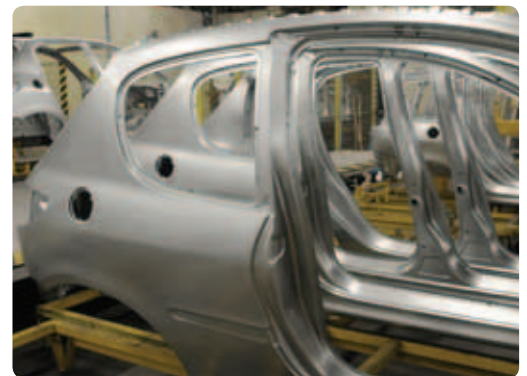
During the production of steel automotive panels, the operator noticed an abnormal sound originating from the press. A cursory inspection found no obvious problem. However, upon a more detailed inspection, it was found that the top sections on 2 of the 4 servo-plungers that controlled the movement of the press had disintegrated.

Initially, it was thought that the cause had been premature metal fatigue due to a material or manufacturing fault. However, a full metallurgical examination failed to establish the exact cause.

The manufacturer advised that the entire set of four plungers will need replacing to ensure proper balancing of the servo-press.
