# Loss Bulletin

## Vero Equipment Breakdown Insurance

### Failure of a copper pipe causes loss of refrigerant

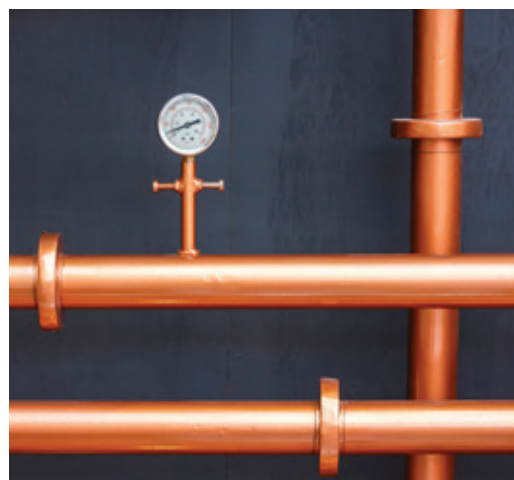
The copper pressure equalisation line on Compressor No. 2 had suffered a catastrophic failure. As a result, the system had lost its complete charge of R22 refrigerant gas.

The failed pipe was replaced, the system was recharged with refrigerant gas and returned to service. The cause of the fault remains a mystery.
