# Loss Bulletin

## Vero Engineering Insurance

### Operator Error Damages Boring Mill

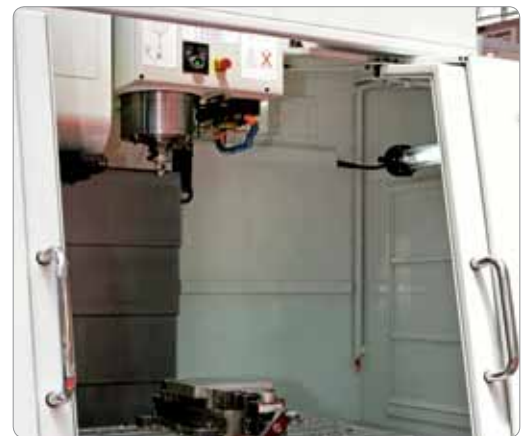
The operator of this machine had changed the machine to manual control to drill holes horizontally in the workpiece. As the cutting head was being withdrawn from one of the holes being machined, the operator proceeded to move the cutting head to the location of the next hole. In his haste, the operator neglected to ensure that the cutting head was fully withdrawn before the assembly was moved vertically. The collision resulted in extensive damage to the cutting head spindle and ceramic shaft bearings.

Despite the fact repairs were fully expedited, it still took almost two months to obtain the replacement spindle assembly from the foreign based manufacturer.
