### Capacitor failure leads to loss of UPS capacity

Data Centre

Uninterruptible Power  
Supply (UPS)

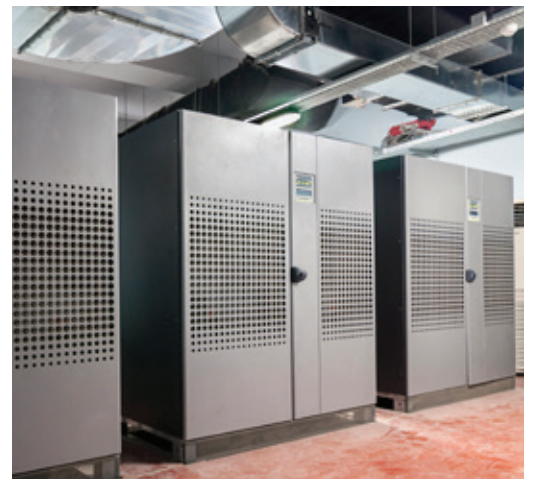
Subsequent investigations revealed substantial damage to the unit, caused by an electrical fault within the DC capacitor bank of the UPS. This fault caused arcing between a number of internal components including the copper busbars to which the capacitors were connected. Partial melting and vaporisation of the copper busbars was the result, with copper being dispersed within the cabinet.

Specialists were engaged and parts were obtained to enable repair of the UPS at a cost of \$498,880.
