Loss Bulletin

Vero Equipment Breakdown Insurance

Wine Manufacturer Bottled Up

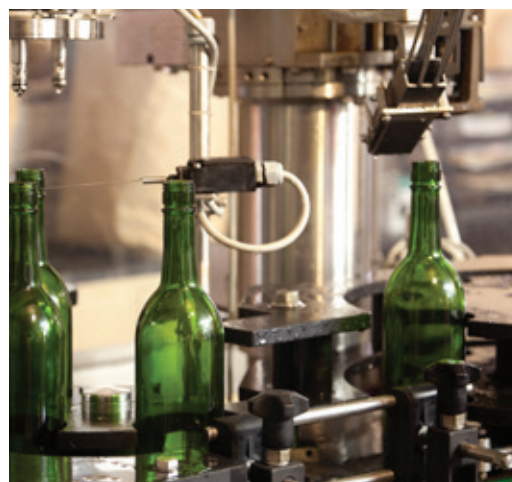
On inspecting the finished product, the operator found disintegrated particles of 'o' rings in some bottles. These 'o' rings were a part of the bottling machine's distribution head, and this indicated some sort of problem with the machine.

The damage was traced back to sudden and premature failure of the chrome surfacing on the bottling machine's head, causing the 'o' ring particles to disintegrate.

The chrome heads were only half their expected design life under normal use, and wear and tear was quickly ruled out as a cause of their failure.

Instead, a Melbourne based factory was hired to re-chrome the damaged machine's head, reducing the whole repair process to just 36 days.
