These common plumbing fittings are a ticking time bomb that can be found in almost any property.

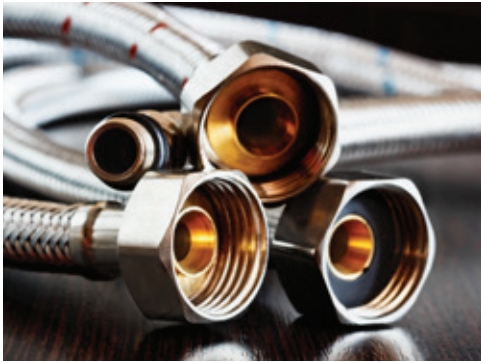
Hydraulic hoses, typically rubber or plastic, that are covered in a braided metal skin that provides additional strength and protection.

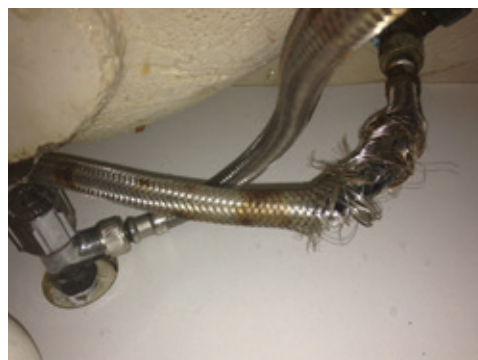
- ▼ Partial failure – a small hole/fracture occurs in the internal pipe wall with a small water leak penetrating through the external metal braided hose.
- ▼ Catastrophic failure – almost simultaneous internal pipe and external metal braid failure resulting in a near or complete and continuing water escape.

- ▼ Eliminate the risk – ideally, replace all metal braided flexible hoses with hard piping.
- ▼ Minimise the likelihood – replacement may not be practical in all cases. Proactive actions that can reduce the chances of the hose failing include:
 - ▼ ensuring product selection and installation guidelines are correctly followed
 - ▼ a regular inspection & maintenance program
 - ▼ a hose retirement/replacement protocol – preferably all hoses should be replaced before they reach five years of age.
- ▼ Minimise the consequences – even with the above risk management controls in place, hose failure may still occur. To help with swift isolation of the water supply a manual water supply closure valve that incorporates an auto reset flood stop mechanism can be installed on the upstream supply.
