Loss Bulletin

Failure of a copper pipe causes loss of refrigerant

Main air-conditioning
plant

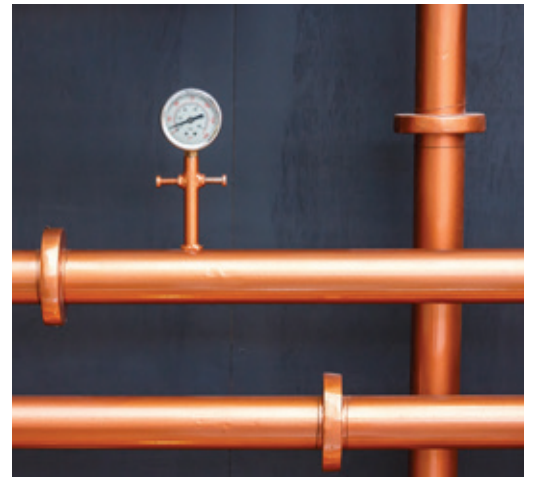
The copper pressure equalisation line on Compressor No. 2 had suffered a catastrophic failure. As a result, the system had lost its complete charge of R22 refrigerant gas.

The failed pipe was replaced, the system was recharged with refrigerant gas and returned to service. The cause of the fault remains a mystery.
