# Loss Bulletin

## Vero Equipment Breakdown Insurance

### Failure of a copper pipe causes loss of refrigerant

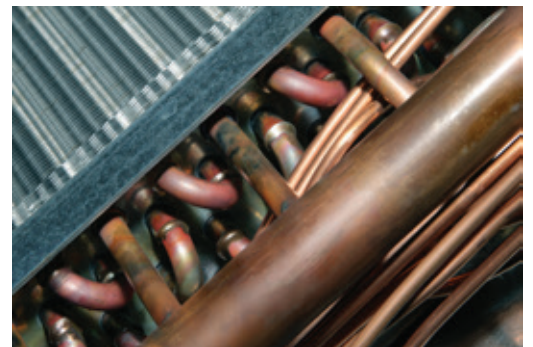
The copper pressure equalisation line on Compressor No. 2 had suffered a catastrophic failure. As a result, the system had lost its complete charge of R22 refrigerant gas.

The failed pipe was replaced and the system was recharged with refrigerant, before being returned to service. The cause of the fault remains a mystery.
