## Vero Equipment Breakdown Insurance

### Power supply switchover results in UPS failure

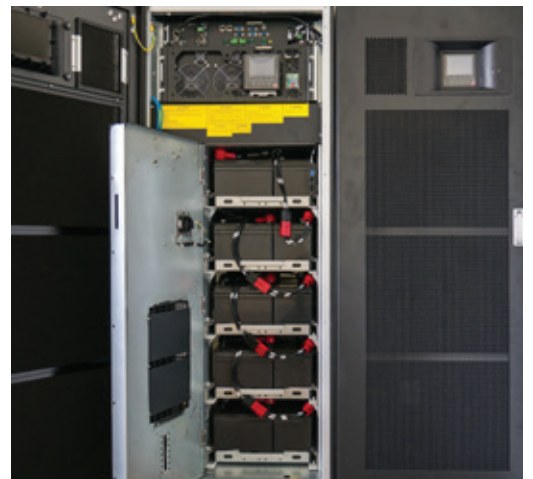
At this time, the insulation within a major component of the main power circuit of one of the UPS units failed, resulting in significant arcing and current flow within the overall UPS power distribution system. Failure of the 1st UPS unit resulted in increased loads on the remaining 2 units, taking them offline in overload mode.

Repair costs for the failed unit included additional specialists costs for inspection, travel and labour due to the specialised nature of the equipment.
