## Vero Equipment Breakdown Insurance

### Corrosion Causes more than high blood pressure in Retirement Home

Retirement Home

Hot Water Tanks and Piping

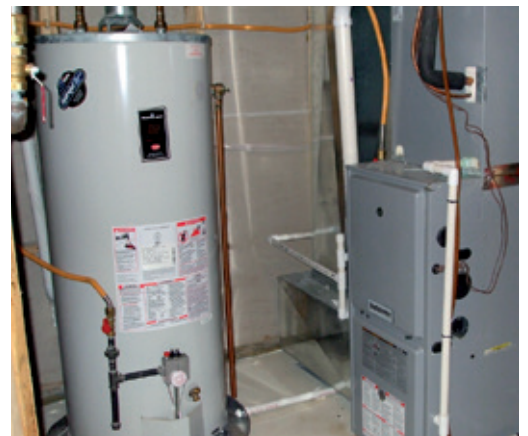
At 3.30am water was noticed flowing down a hallway at a Retirement Home. Emergency maintenance staff attended the site and found the leak to be coming from a hot water heater. The maintenance staff turned off the water supply at an isolating valve, and contacted the home's contract plumber, who arrived on site at 7.00am. The plumber found that three hot water heaters in two other buildings in the complex had also ruptured and leaked. The cause of the leaks was eventually determined to be overpressure in the water supply caused by a faulty pressure reducing valve located in the incoming water pipework at the estate boundary. The pressure reducing valve had been damaged by corrosion. The total damage included not only replaced water heaters, but coils and water circulating pumps.
