Loss Bulletin

Computer Numerical Control (CNC) lathe turret knocks out chuck jaw

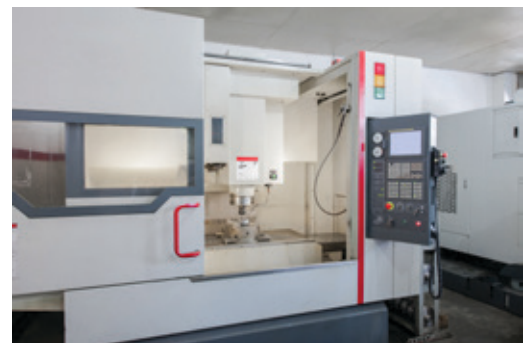
Weekly general maintenance and thorough bi-annual servicing could not prevent extensive damage when the tool turret of a CNC lathe collided with the job material in its chuck jaw. The impact between the live tool in the turret and the chuck jaw caused the body of the tool turret to lift, causing extensive damage to the tool turret, cross slide, chuck and spindle of the machine.

The repairs to the machine included replacing the damaged turret body, cross slide and saddle, disconnecting and reconnecting the mains power supply, and lifting the lathe out and then back into position.
